INDOOR AIR QUALITY ASSESSMENT

**Department of Children and Families
30 Mystic Street
Arlington, MA**

Prepared by:
Massachusetts Department of Public Health
Bureau of Environmental Health
Indoor Air Quality Program
December 2018

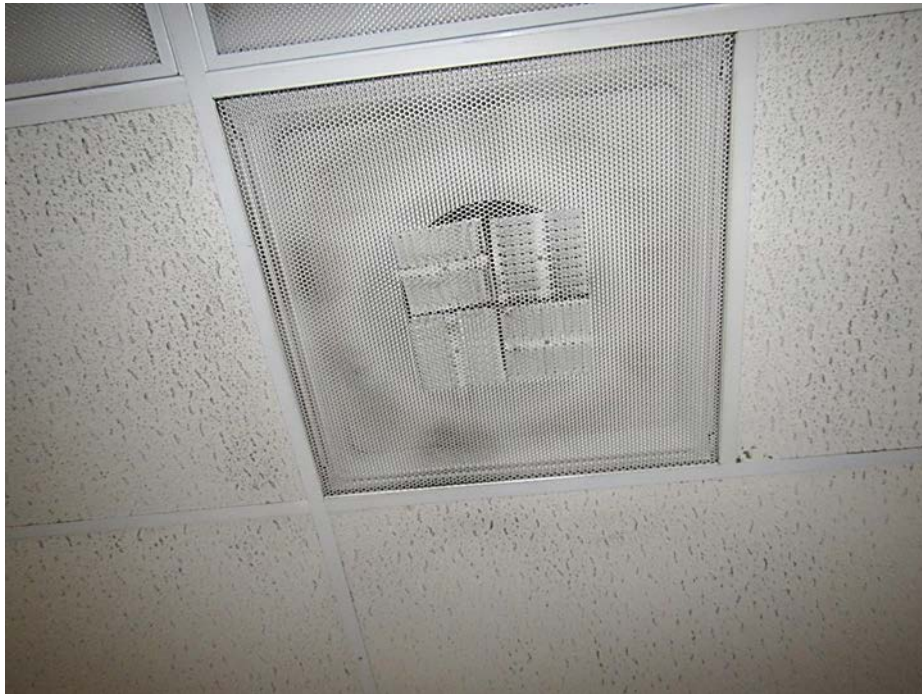
Picture 1

Fresh air is provided by air-handling units (AHUs) located on the roof. Operation of the building's HVAC system is controlled by an automated computer system. Air from the AHUs is filtered, heated/cooled, and delivered to rooms via ducted supply vents (Picture 1). Air is returned/exhausted through return vents (Picture 2). It is recommended that HVAC systems be re-balanced every five years to ensure adequate air systems function (SMACNA, 1994). It was reported that exhaust vents in the restrooms and kitchen areas vent directly outside. Direct-vented exhaust is recommended in areas where moisture and odors may be generated.

In many areas, supply and return vents were dusty (Picture 1; Table 1). Personal fans also had dust build-up. These should be cleaned periodically to remove dust which can be reaerosolized and cause irritation. Note that the vent shown in Picture 3 had been covered due to occupant concerns with dust/debris in the office that was attributed to the vent. While no debris was present during the assessment, the occupant reported that dust/debris continues to occur with the vent covered. The occupant should report this dust/debris when it occurs to facility maintenance staff to assist in determining the source, such as disturbed ceiling tiles, plenum pressurization or other issues.

Typical supply vent, note dust on vent

17. Clean carpeting in accordance with IICRC recommendations (IICRC, 2012).
 18. Clean supply and exhaust vents, personal fans, and heaters regularly to prevent aerosolization of debris.

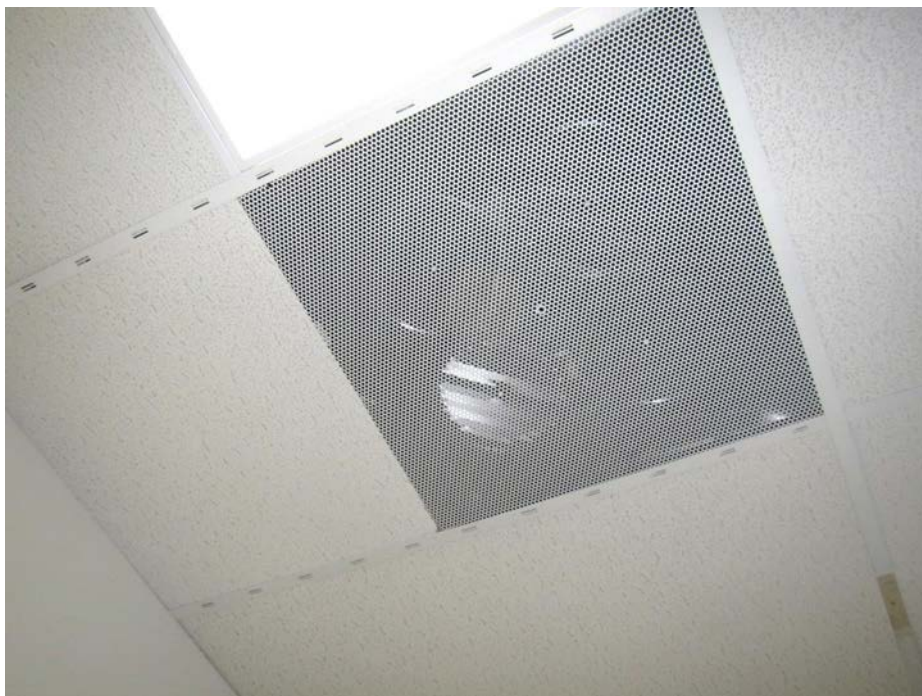
Picture 2

Return vent

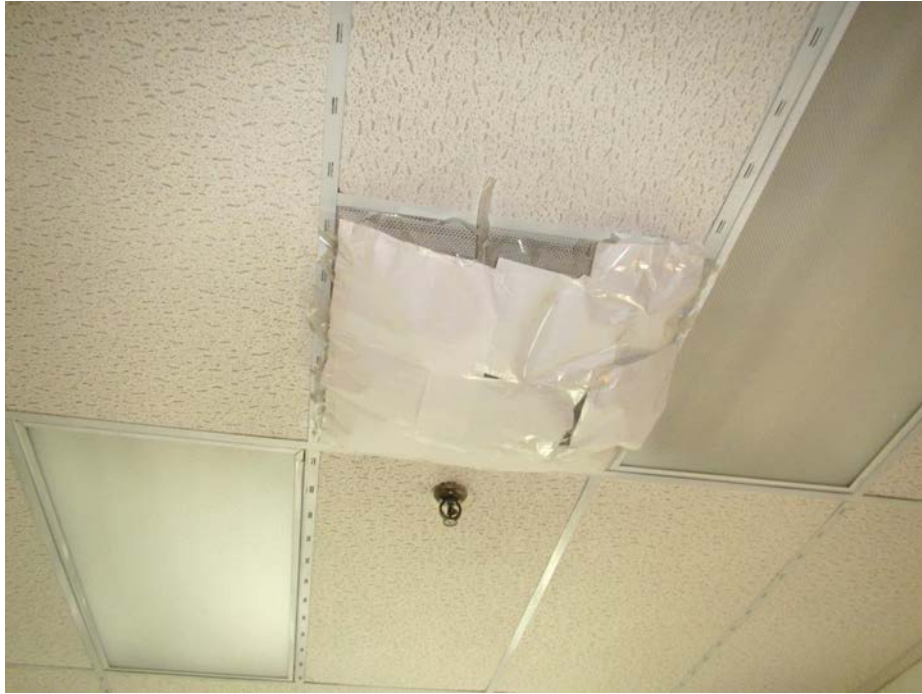
Picture 3

In a few areas, supply vents were blocked with plastic or cardboard (Pictures 3 and 4). Vents should remain unobstructed for proper airflow once the system has been balanced. If there are concerns regarding drafts or noise, building maintenance staff should be contacted for adjustments of the system.

Vent blocked with plastic

1. Operate supply and return ventilation continuously (“fan on”) during occupied periods.
2. Remove obstructions (paper, plastic) from vents. If drafts, noise or other issues are of concern, work with building maintenance staff to resolve.

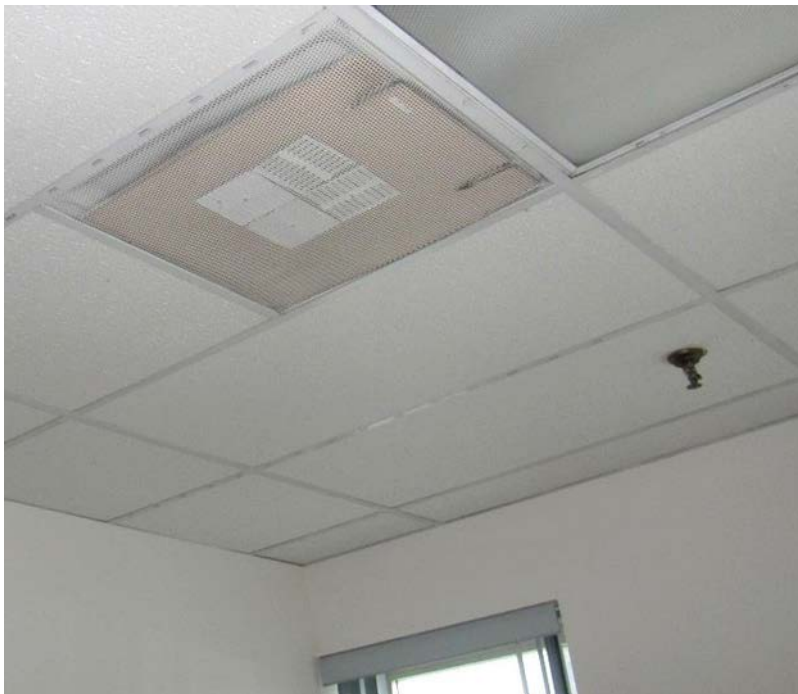
Picture 4

Vent blocked with cardboard

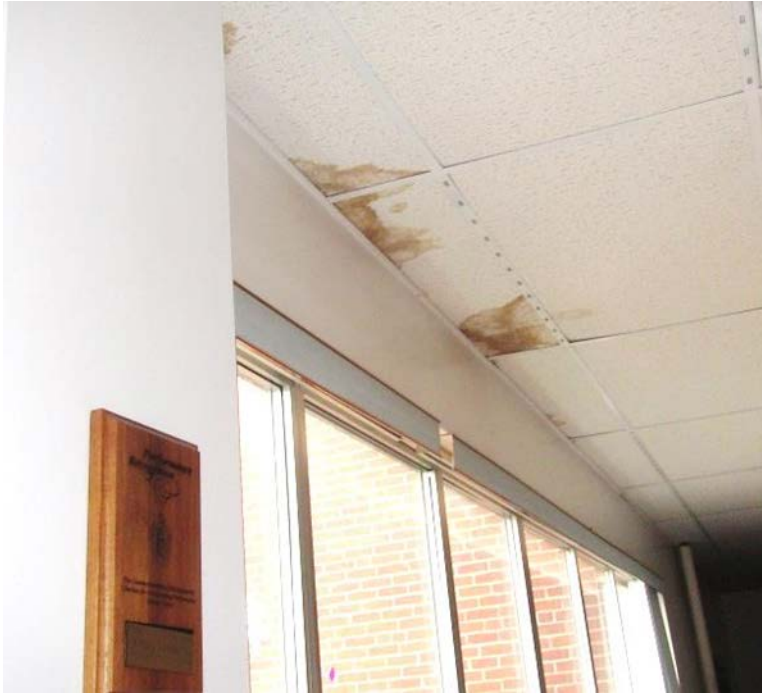
Picture 5

Water-damaged ceiling tiles were found in several offices and other areas (Pictures 5 and 6). Some of the water-damaged tiles were near the edge of the building and may be related to leaks through the building envelope. Other water-damaged tiles originate with leaks from the plumbing or HVAC system. Water-damaged tiles should be replaced when the leaks are

repaired. The area above/around the water-damaged tiles should be examined for moisture and odors and remediated as necessary.

Water-damaged ceiling tiles next to windows

7. Replace water-damaged ceiling tiles. Inspect area above the water-damaged tiles for other water damage or odors and clean or repair as necessary. If water damage continues to occur, identify and repair the leaks.

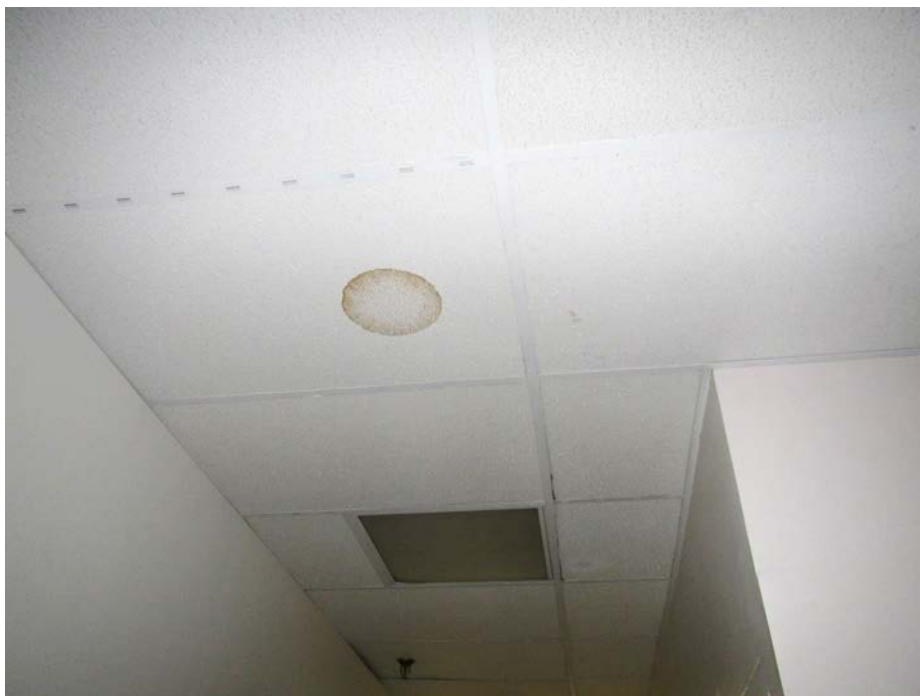
Picture 6

Water-damaged ceiling tile

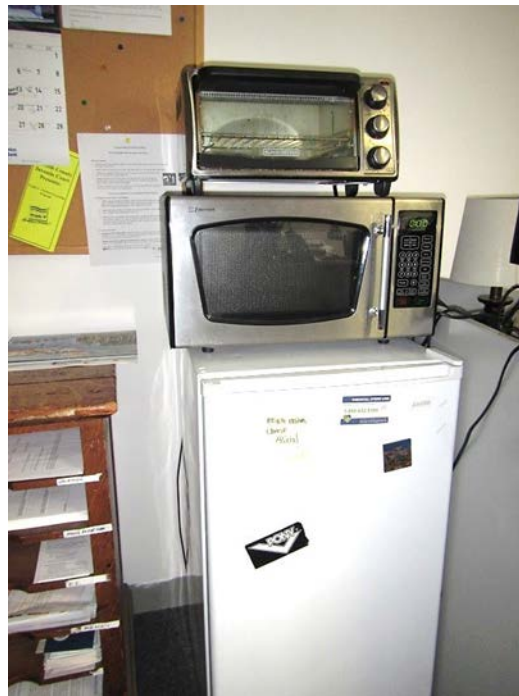
Picture 7

Several water coolers and refrigerators were located in carpeted areas (Picture 7). Spills or leaks from these appliances can moisten the carpet, leading to odors and microbial growth. Refrigerators should be kept clean and free of spills and spoiled food that can lead to odors. The large number of small refrigerators presents a challenge in keeping all of them clean (Picture 8).

Refrigerator on carpet

8. Avoid placing porous items (cloth, boxes) in areas with potential water leaks such as windowsills.
 9. Place refrigerators and water dispensing equipment in areas without carpeting or use a waterproof mat underneath them.

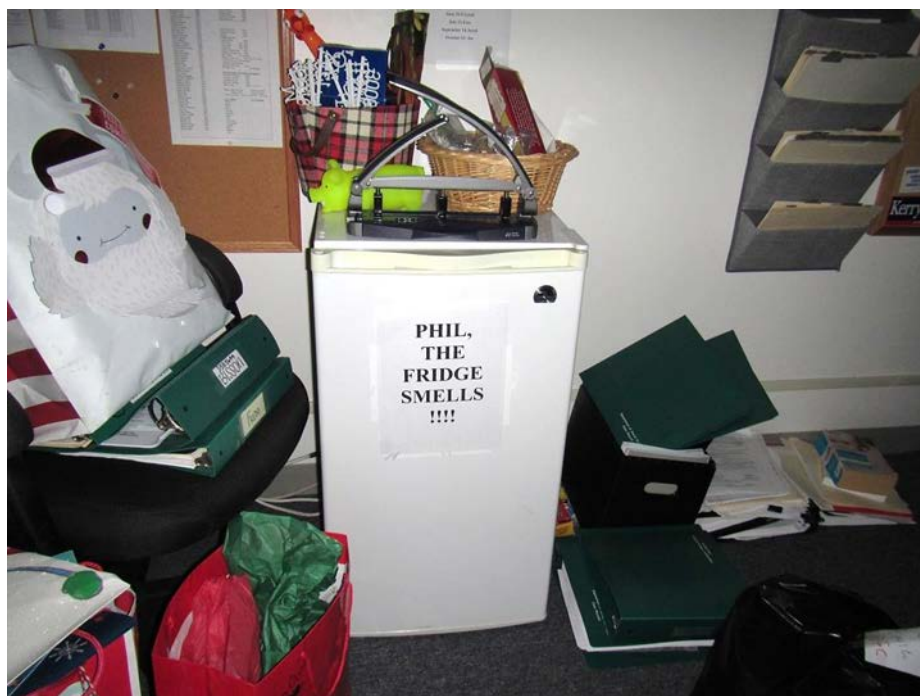
Picture 8

Refrigerator sign, note items on floor

10. Ensure all refrigerators are cleaned regularly to remove spoiled food and spills.
 11. Keep plants in good condition, avoid overwatering, and avoid placing them on porous materials.

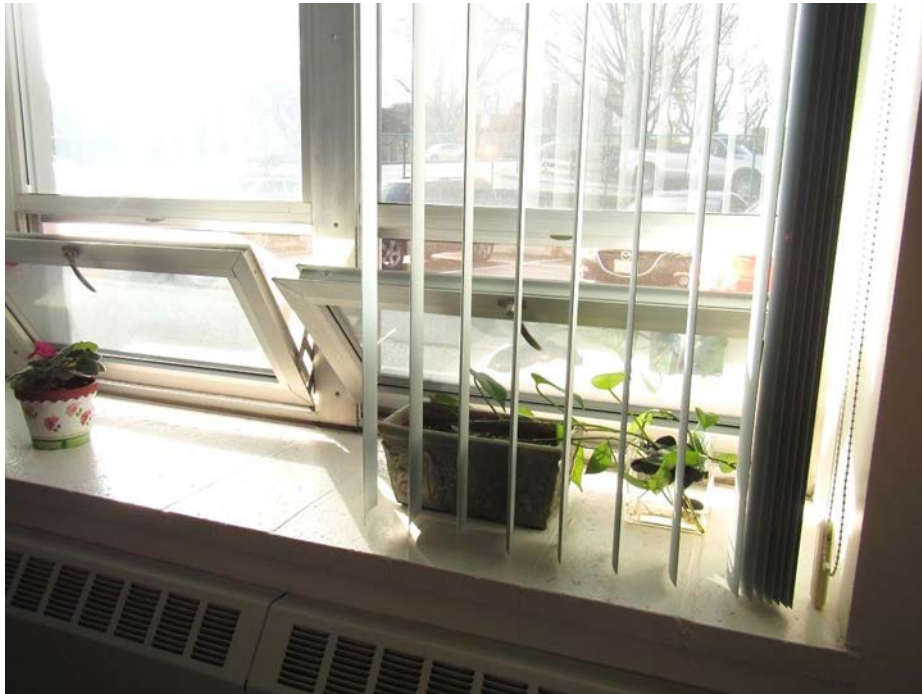
Picture 9

Plants were present in some areas (Pictures 9 and 10; Table 1). Some of the plants were in poor condition. Plants can be a source of pollen and mold, which can be respiratory irritants to some individuals. Plants should be properly maintained and equipped with drip pans to prevent water damage to porous materials. Plants should also be located away from air diffusers to prevent the aerosolization of dirt, pollen, and mold.

Plants on windowsill

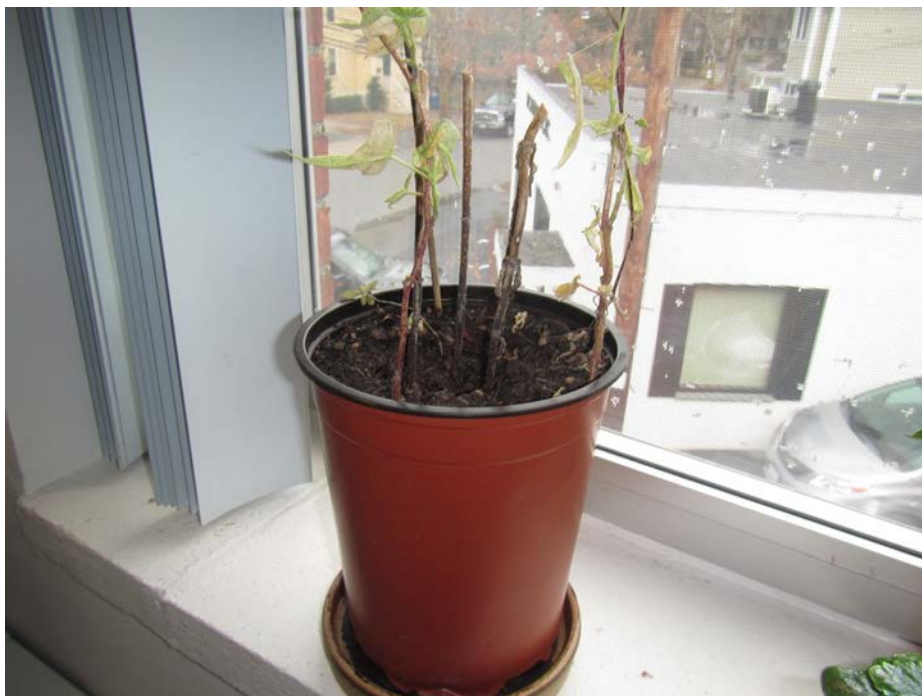
Picture 10

Plant in poor condition in an office

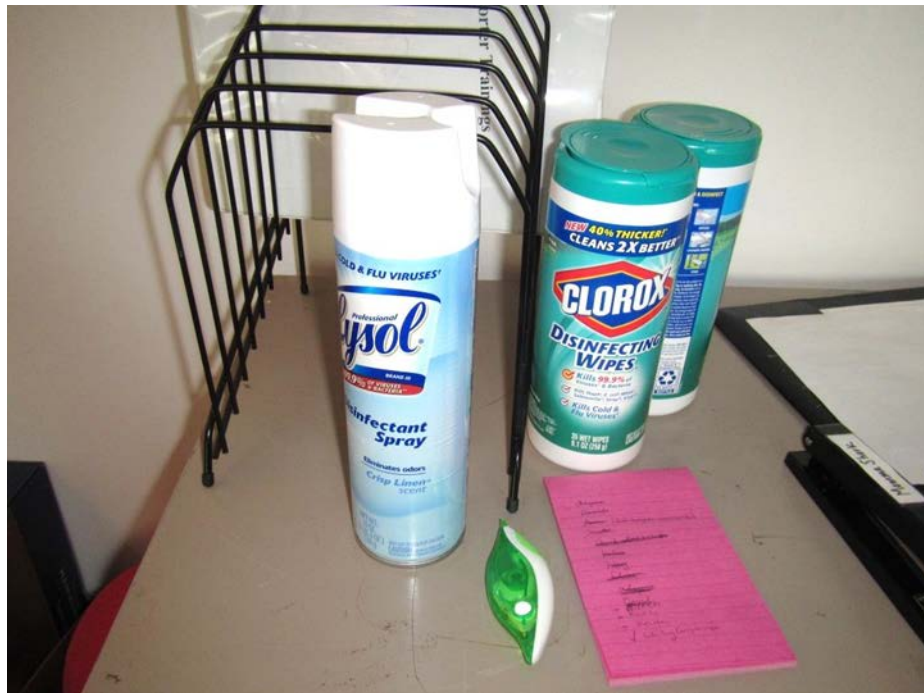
Picture 11

Exposure to low levels of total volatile organic compounds (TVOCs) may produce eye, nose, throat, and/or respiratory irritation in some sensitive individuals. To determine if VOCs were present, BEH/IAQ staff took measurements for TVOCs and examined rooms for products containing VOCs. While no TVOCs above background were detected, BEH/IAQ staff noted dry erase markers, cleaning products, air freshening products and hand sanitizers in use within the building (Picture 11; Table 1). All of these products have the potential to be irritants to the eyes, nose, throat, and respiratory system of sensitive individuals.

Cleaners/sanitizers in an office

12. Trim back trees and plants adjacent to the building.
 13. Reduce use of cleaning products, sanitizers, and scented products.
 14. Keep food in tightly sealed containers and keep kitchen equipment clean.

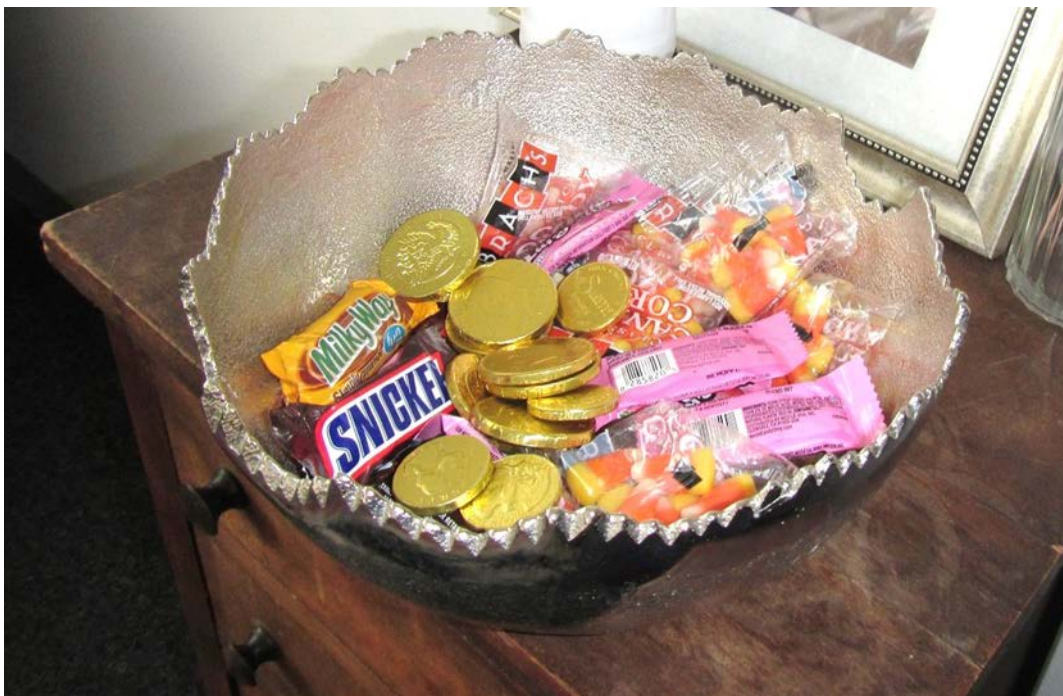
Picture 12

Several office areas contained food (Picture 12; Table 1). Food should be stored in tightly-sealed containers to prevent odors and pests, particularly since rodents had been observed in the building. Kitchen equipment such as toasters and microwaves should also be cleaned regularly.

Food in an office
